DEPARTMENT OF NATURAL RESOURCES  
DIVISION OF OIL, GAS AND MINING

May 31, 1994

RE: Site Inspection, Interstate Brick Company, Big Cottonwood Mine, M/035/003, Salt Lake County, Utah

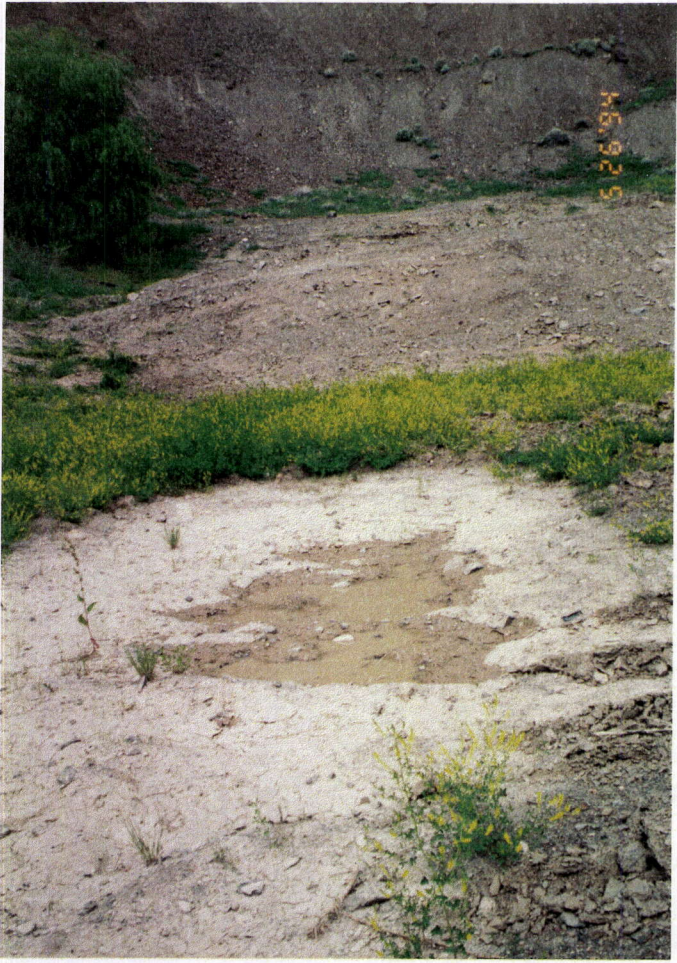
"natural sediment trap"  
at north end of site

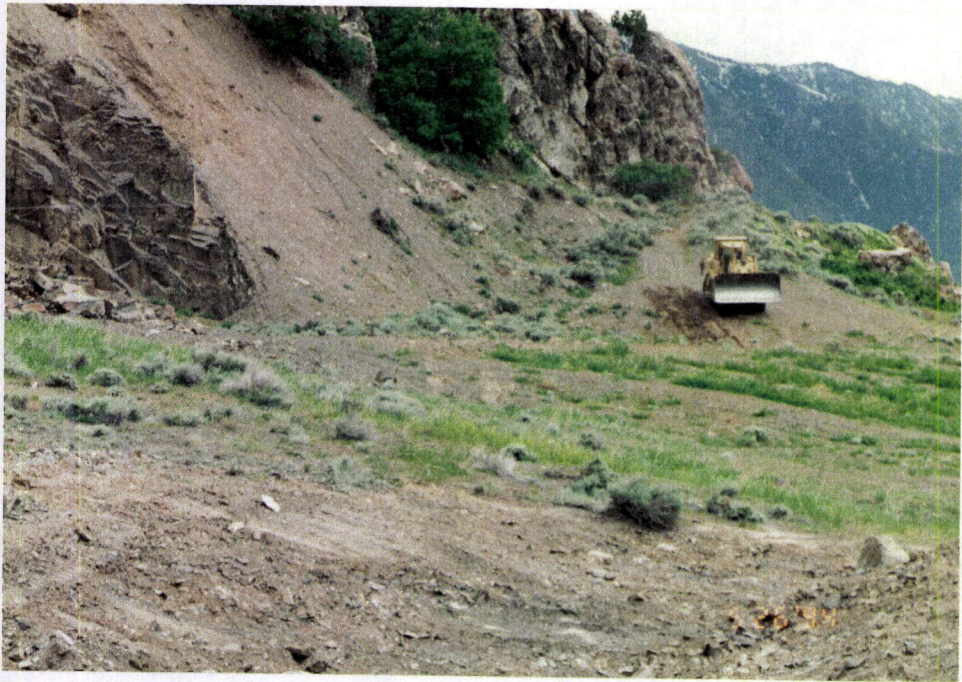
Several areas of the pit floor had little vegetative growth because of excessive compaction. We requested that these areas be ripped. We also requested that the site be scarified just prior to seeding.

M/035/003  
dozer ripping compacted areas

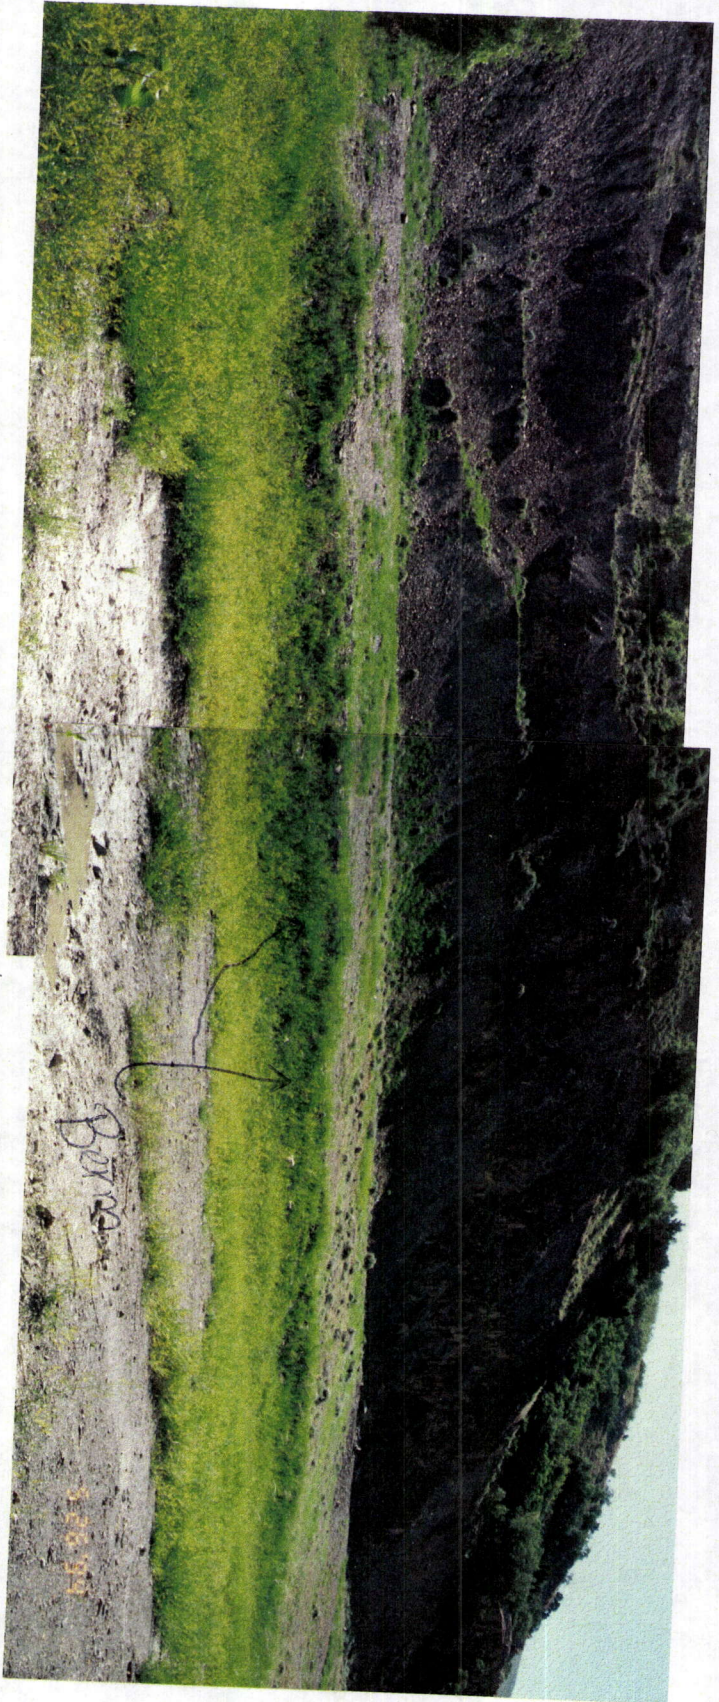
We walked over the site and observed that most of the ripped asphalt was used to construct the berm. Enlargement of the berm to plan specifications sufficiently buried the exposed asphalt. The berm crest, before final improvement, was approximately three feet above the upper pit floor and approximately 200 feet in length. Plans required the berm height to be at least six feet above the upper pit floor and the berm length be at least 230 feet (see map titled "Grading and Reclamation Plan" received by the Division on March 4, 1991).

M/035/003  
Highway 11  
Berm before improvement

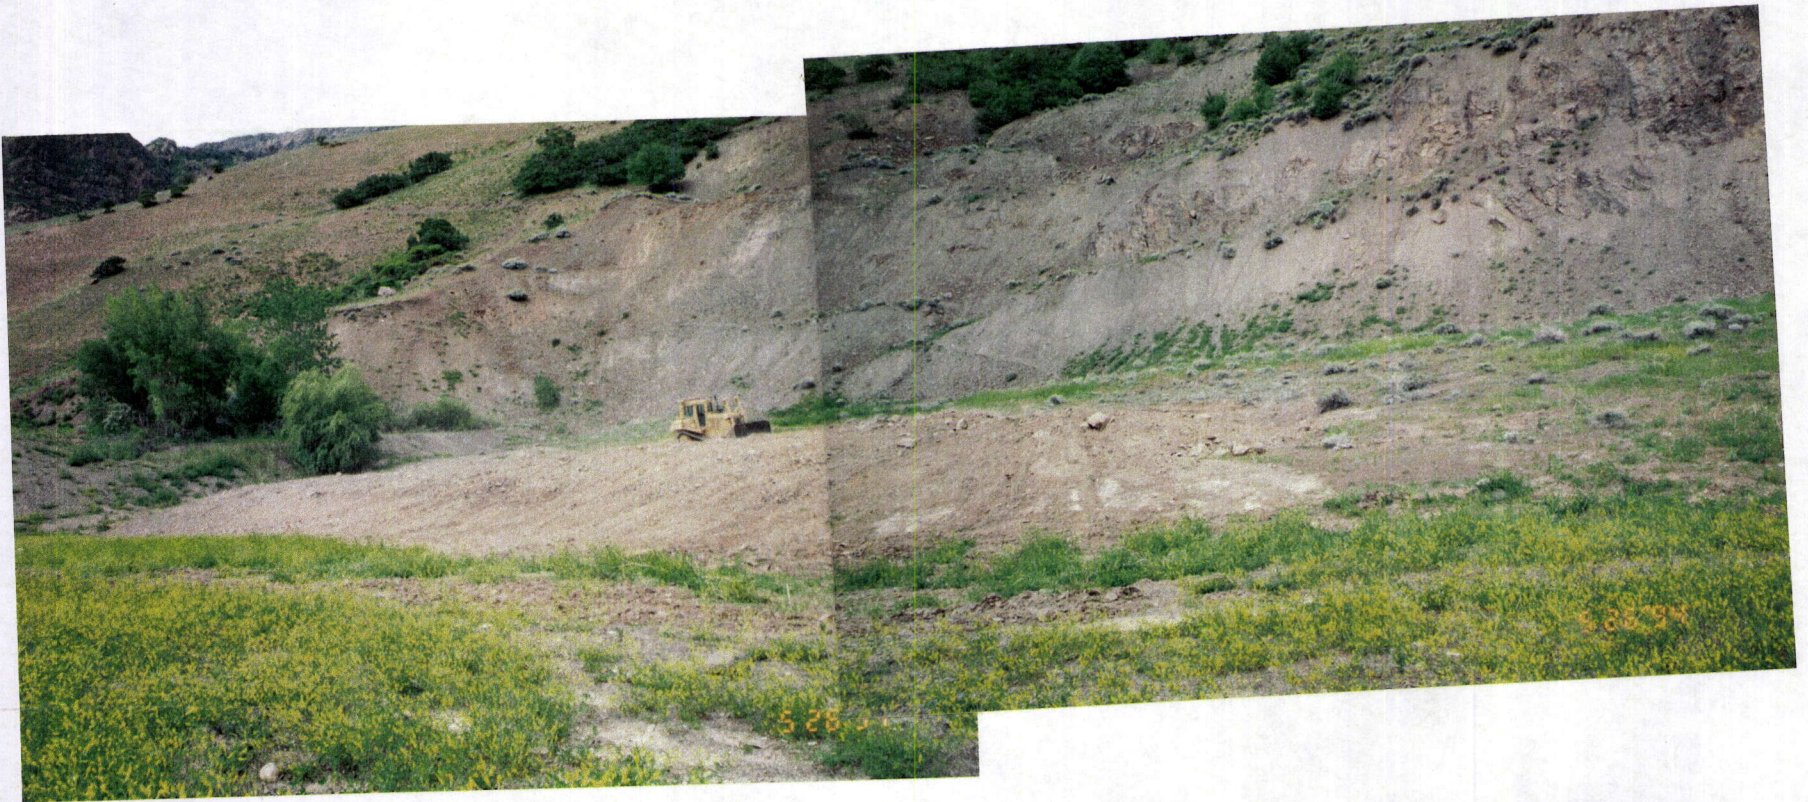
When we returned in the afternoon, we measured the new berm length to be 235 feet. The new berm height was built up to about seven or eight feet above the upper pit floor. The berm outslopes were built in accordance with the approved plan. Areas of compaction had been ripped.

M/035/003  
Berm after construction  
view facing East

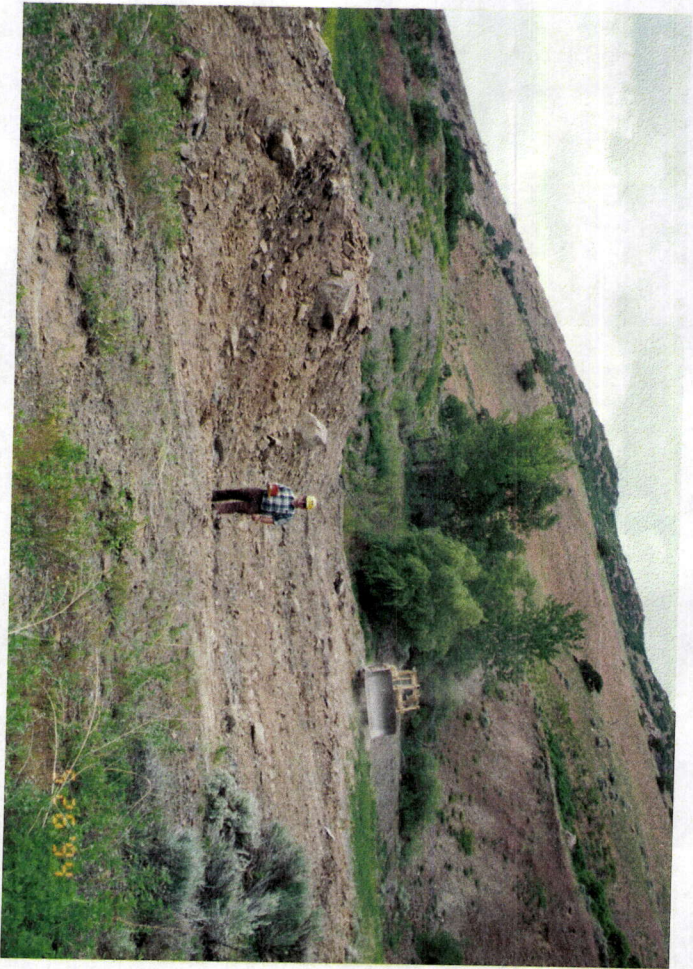
M/035/003

Berm after construction/improvement  
view facing North

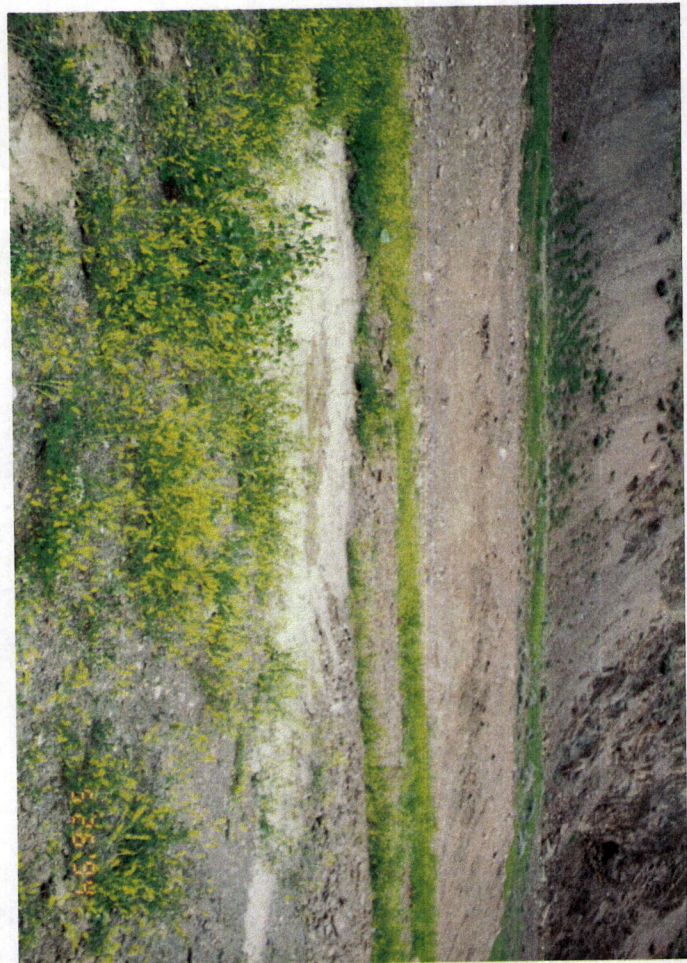
M/035/003

ripped areas  
facing NW

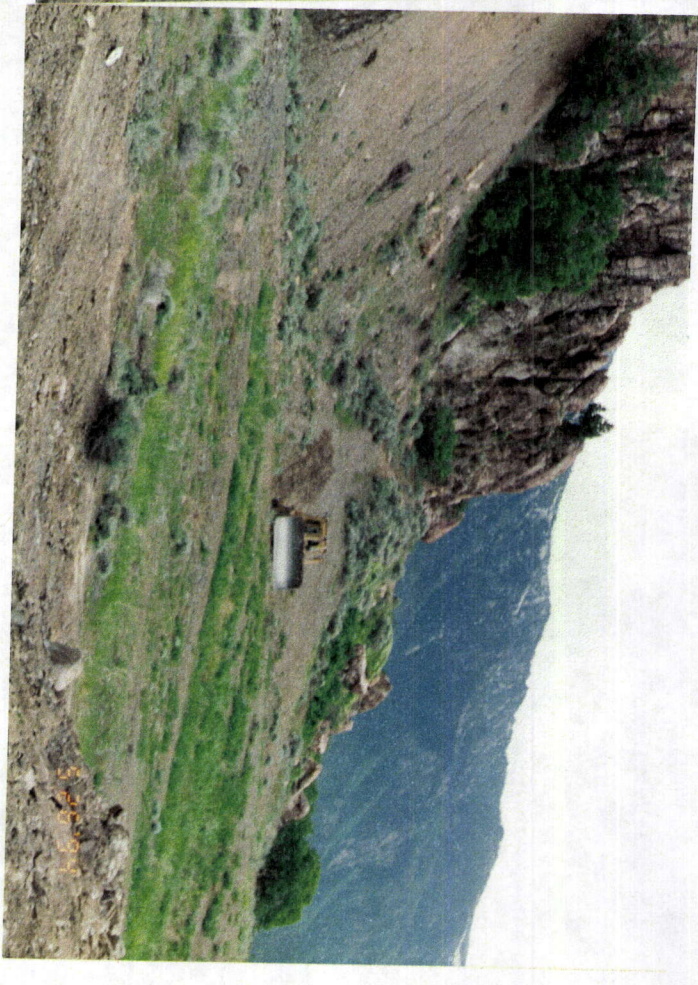
M/035/003

Berm before improvement  
view facing South

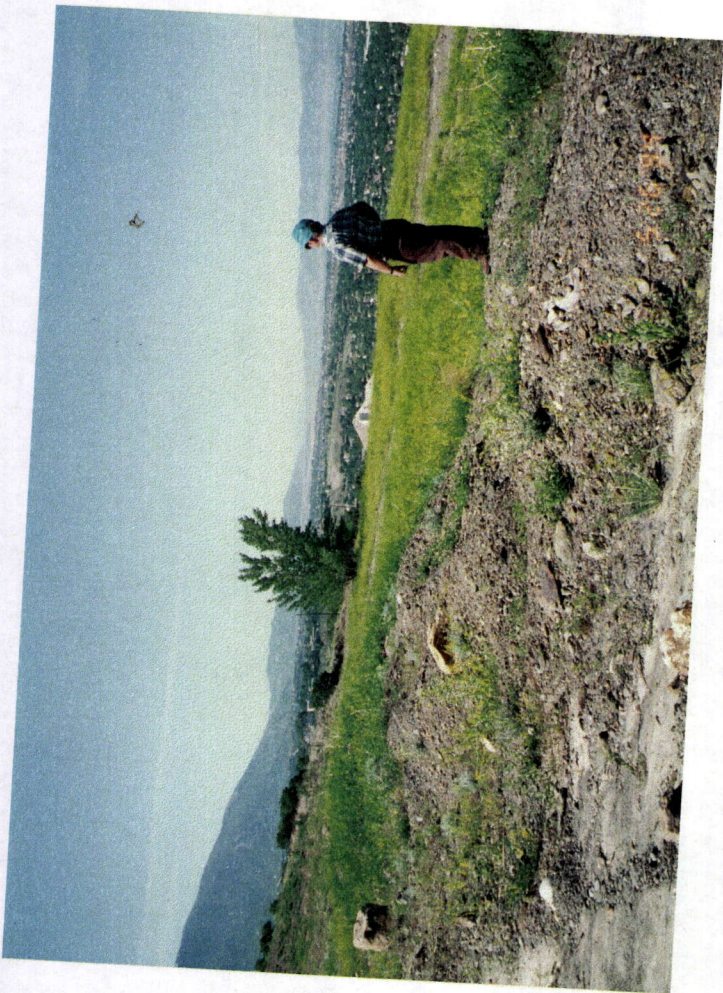
M/035/003

deeper ripping compacted areas

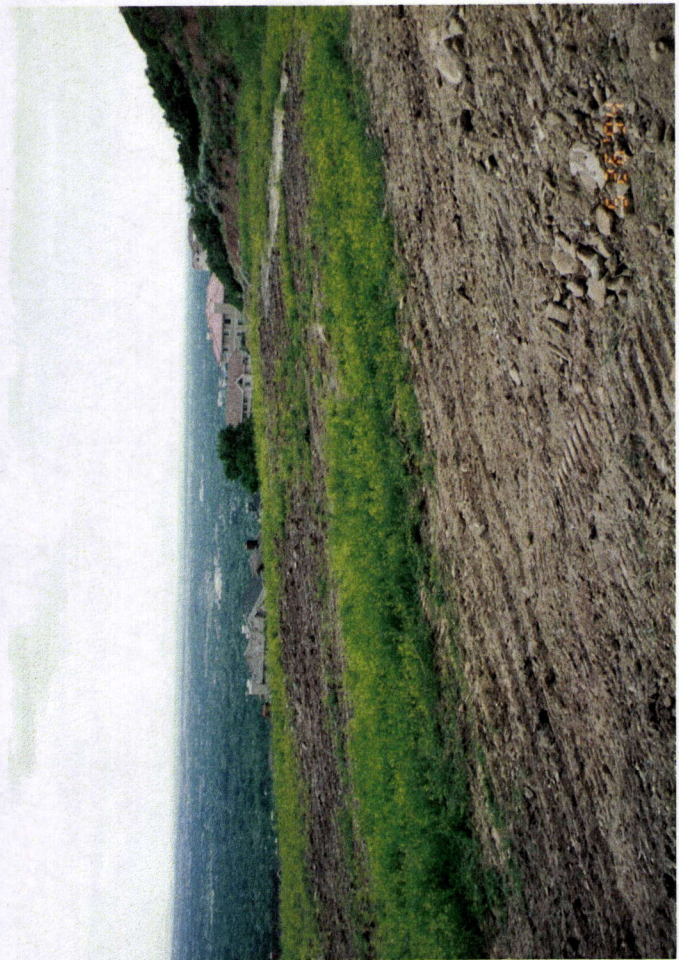
M/035/003

Berm after improvement  
facing east

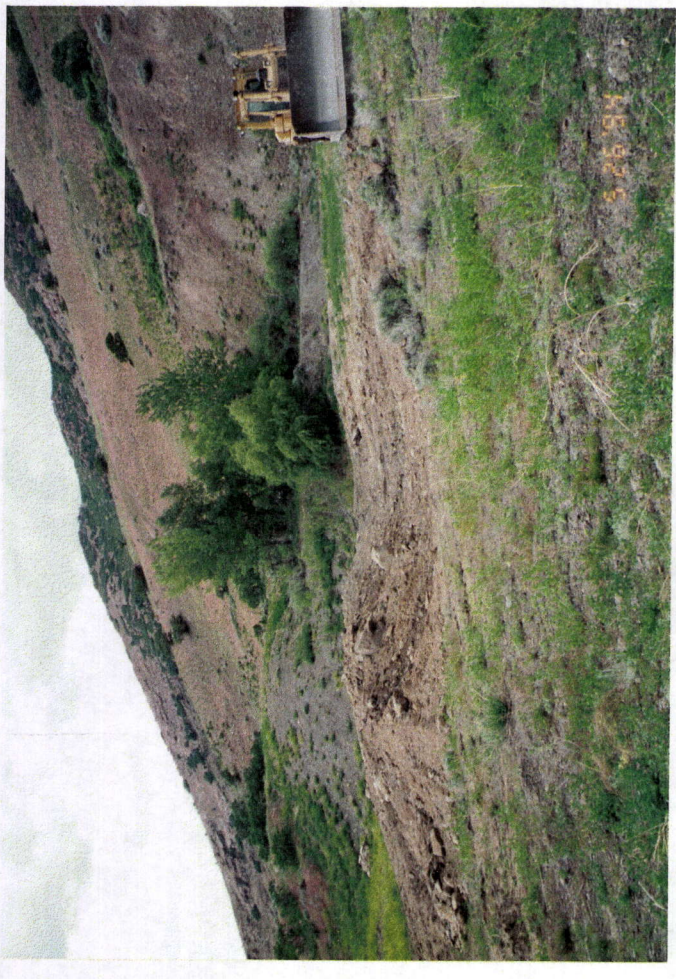
M/035/003

Berm after improvement  
facing north
